Report on the Grebe nesting colonies on Lake Hodges, Monday 9th Sept 2021,

by Brian Caldwell of Lake Hodges Photo Tours.

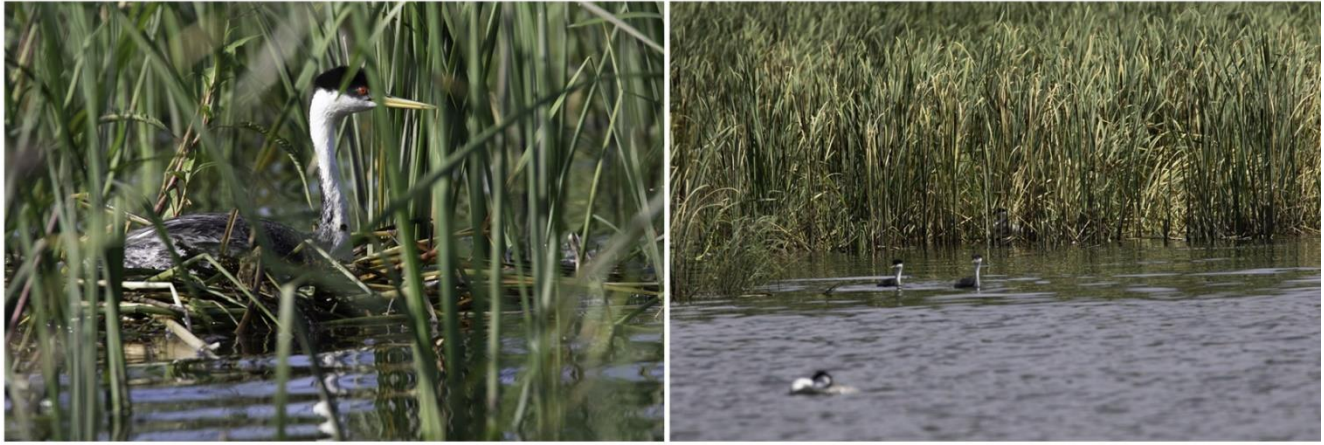
Figure 2

- The actual number of eggs per nest cannot be determined without disturbing the colony but on average, Grebes lay 2-3 eggs per clutch. Active nests were recorded when an adult was observed sitting on a nest incubating eggs. The difficulty in observing nests from shore is apparent in figure 2. The left photo was taken from the water. The right photo was taken from the shore.

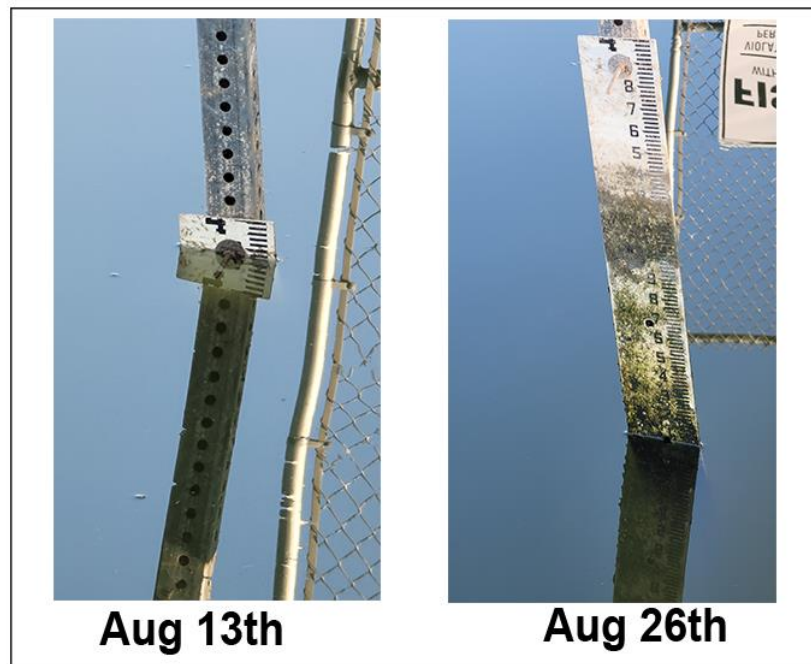
The Lake level fluctuated several times within the observation period from a peak depth of 93.9' on Aug 13th to a low of 92' on Aug 26th, vertical difference of a 22.9". Figure 3 shows the 2 gauge readings of Lake Hodges taken at the main launch ramp. At the nesting sites this difference in the water level amounts to a 50 - 75 yard horizontal reduction of the shoreline.

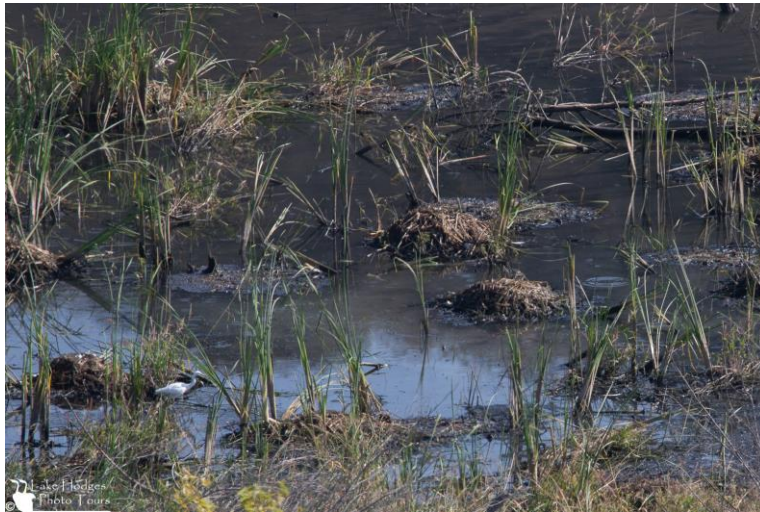
Figure 4

On Aug 27th the water level dropped to the point where all the nests were abandoned as shown in figure 4.

- Using observations of previous years, had the water not fluctuated, it is likely the success rate would have been significantly higher. The suggested protocols set in place after the large colony failures of 2019 appeared to have been ignored by the City of San Diego, SDG&E and San Diego County Water Authority.

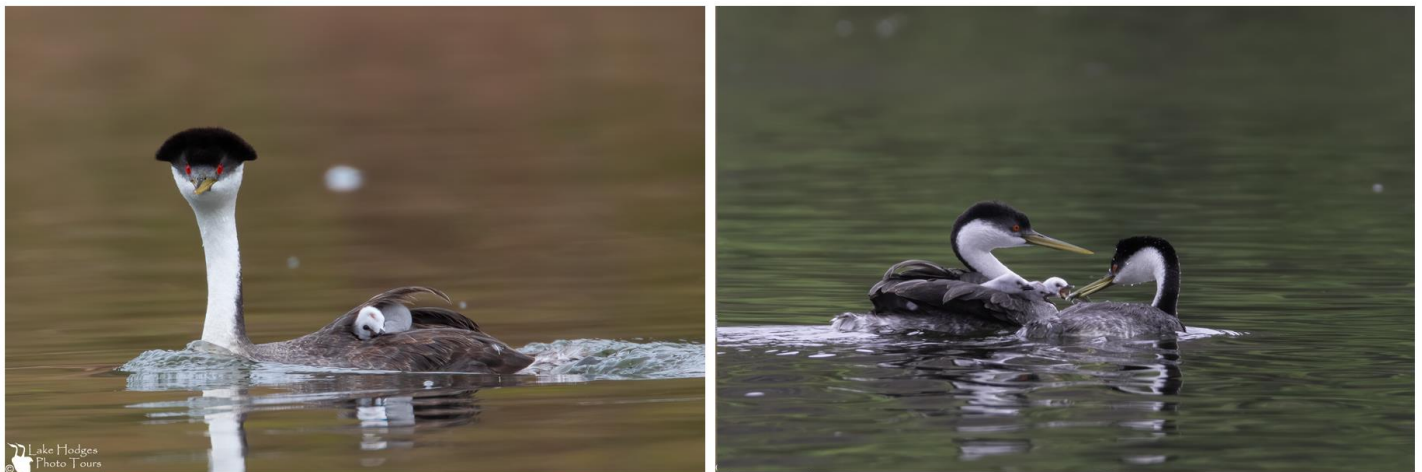
-Knowing that ambiguous results can occur when trying to count chicks in the first week after hatching we waited until Sept 4th, ten days after the colony failure to eliminate false positives. If the chicks are hidden under the feathers of the parents at this age even the less experienced can discern the distinct hump on the back of the parents regardless of the chicks being visible themselves. Figure 5 shows an example of a parent in the first week after the colony collapse. At this stage in their development it is not uncommon for observers to miscount the number of chicks, or count chicks when there are none. There are actually 3 chicks riding this same parent. The 2 photographs are of the same bird taken on the same day.
